**DEMO - Nedmore
Towers / EEI Imaging
Sample Inspection**

This report is the result of a sample inspection conducted by Needmore Towers / EEI Imaging on a site representative of client's needs.

| Name | Credit River Tower |
| Tower Type | AI 333 GT |

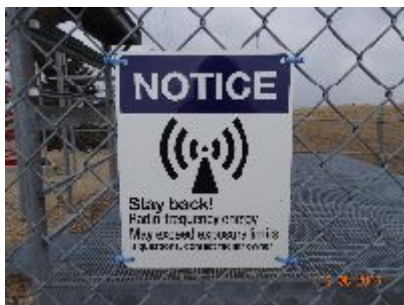
2b5

One RF sign on Sprint Gate, nothing on tower or shelter

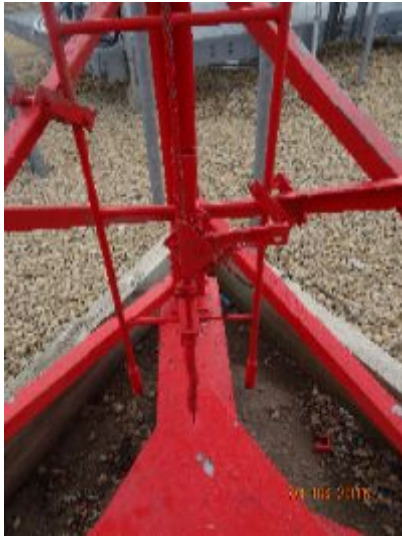
2c1

Safety climb is painted

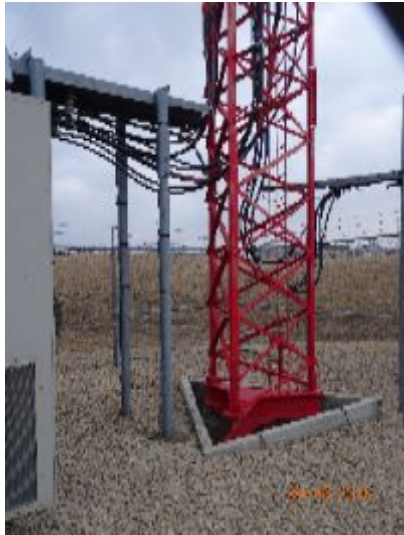
**2b7****c** Site / Foundation Details

No manufacturers labels on tower

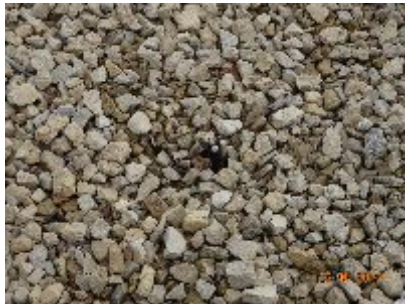
**2d1**

Trip hazards where old shelter was removed

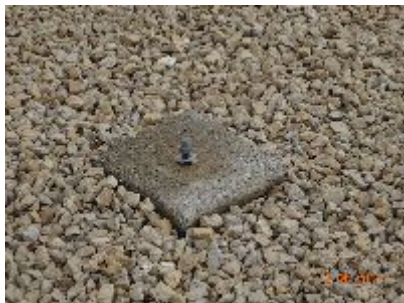
**2d2**

Trip hazard

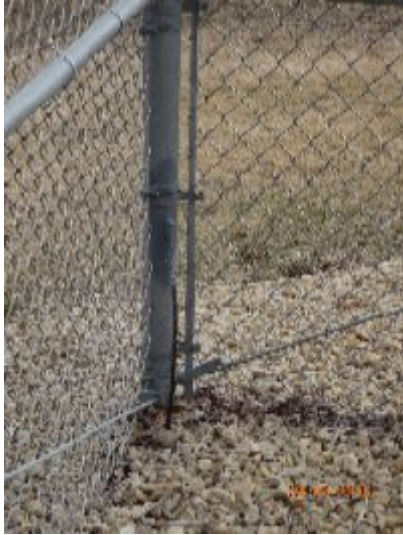
3c3

Corners Grounded

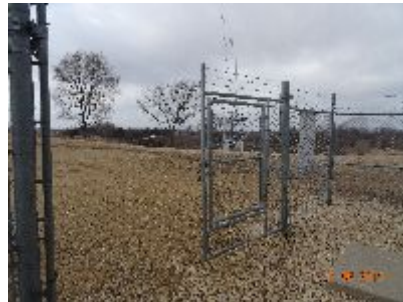
3c4

Sprint gate hardware loose and gate lifts off of hinges

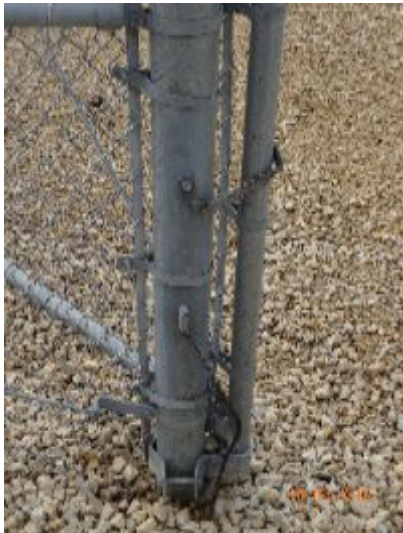
3c5

Gates grounded

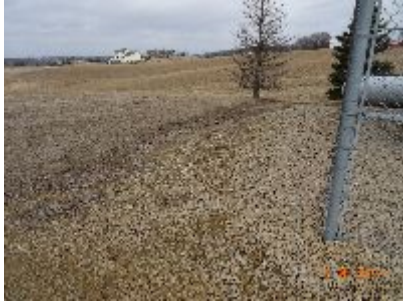
**3c7**

good site grounding outside of compound

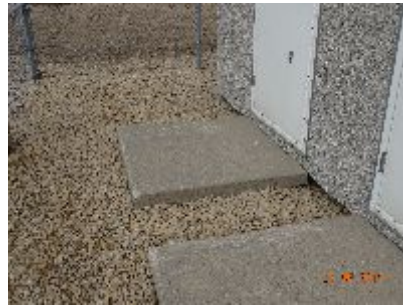
**3c6**

Soil settlement near building has created negative drainage

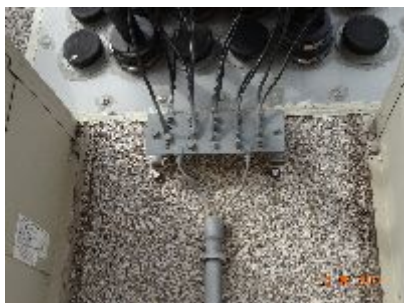
**3g1**

Ground bar at antenna entry port

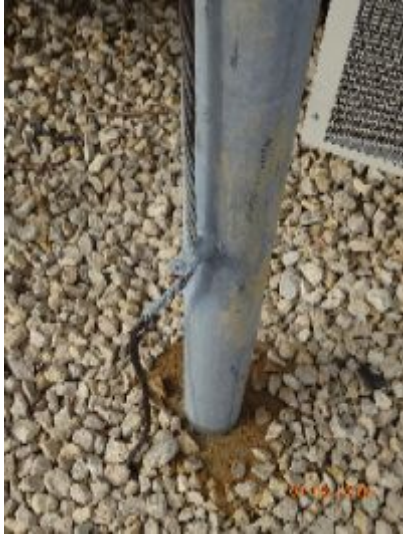
**3g2**

Ice bridge is grounded

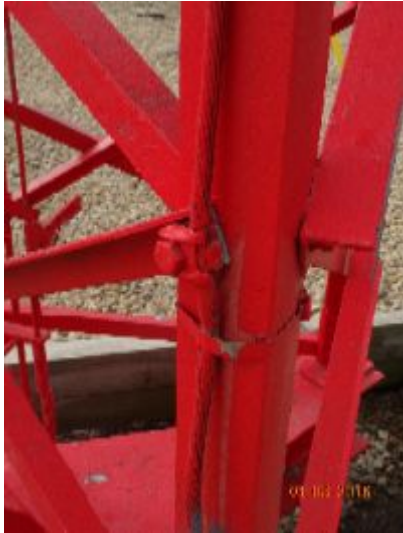
**3g3**

Tower is properly grounded
