**DEMO - Nedmore
Towers / EEI Imaging
Sample Inspection**

This report is the result of a sample inspection conducted by Needmore Towers / EEI Imaging on a site representative of client's needs.

| Name | Credit River Tower |
| Tower Type | AI 333 GT |

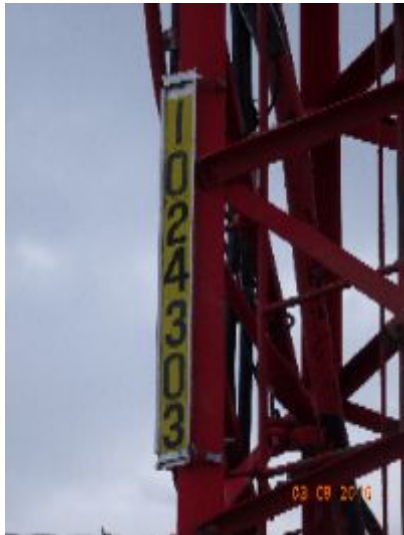
2b6

One RF sign on Sprint Gate, nothing on tower or shelter

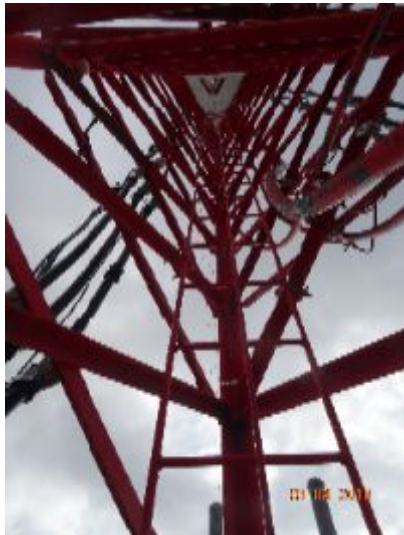
2c2

Safety climb is painted

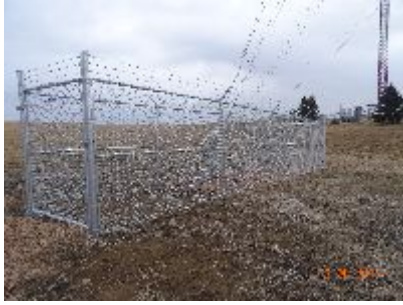
3c a1

New Alpha Anchor

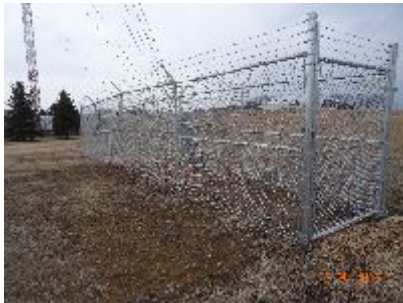
3c b1

New Beta Anchor

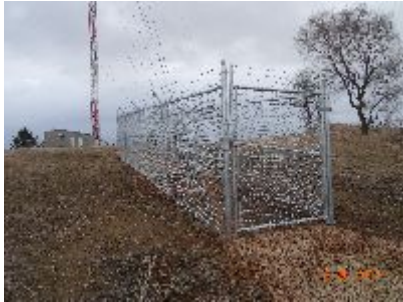
**3c c1**

New Gamma Anchor

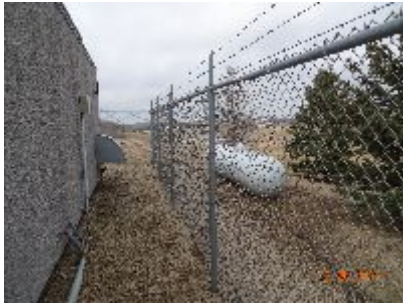
3c1

Site fence

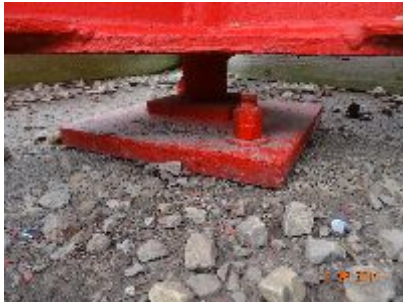
**3d**

Base

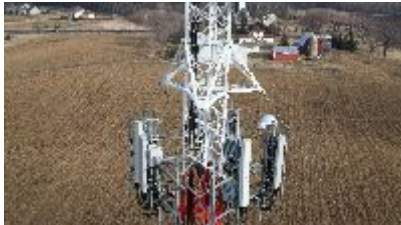
**3d10**

Torque arm @ 265.8

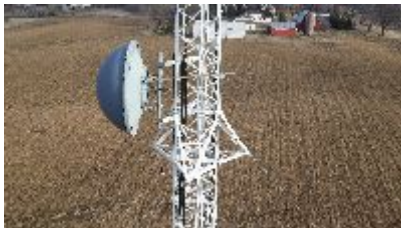
**3d11**

Torque arm @ 110.25

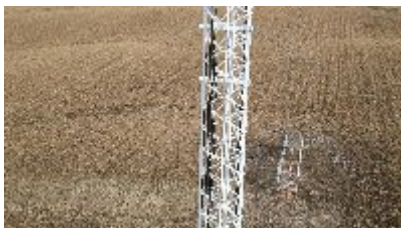
**3d12**

Guy Attach @ 59.2

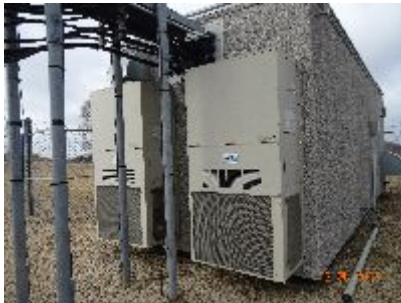
3e1

Bard HVAC units

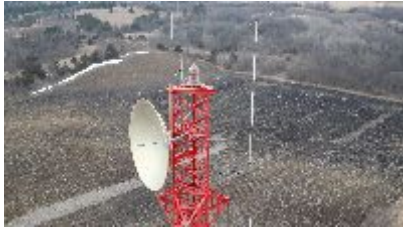
**3h2 alpha**

10' dish @ 215.25 center

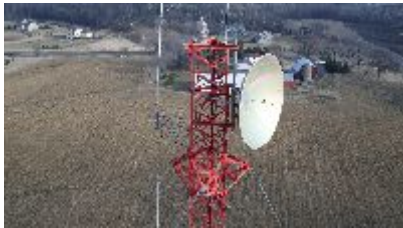
**3h2 beta**

18' whip @ 209.5 base of mount

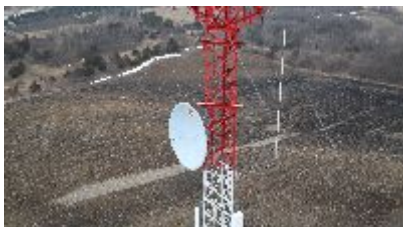
**3h3 alpha**

8.5 dish @ 191.25 center

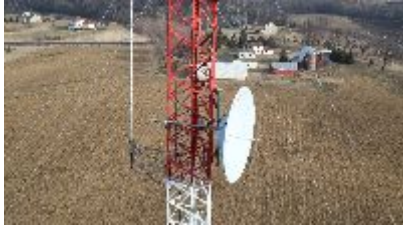
**3h3 beta**

18' whip @ 185.2

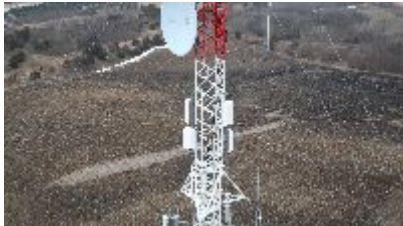
**3h4 alpha**

700 MHz array centered @177.25

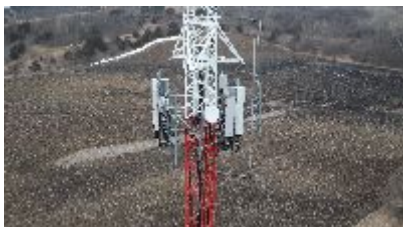
**3h5 alpha**

Sprint array mounts @ 160
